INCIDENT REPORT

REPORT ON INVESTIGATION OF THE
COLLISION BETWEEN
THE TANKER "LOCH RANNOCH" AND
TUG "SOLAN" ON
20 DECEMBER 2011

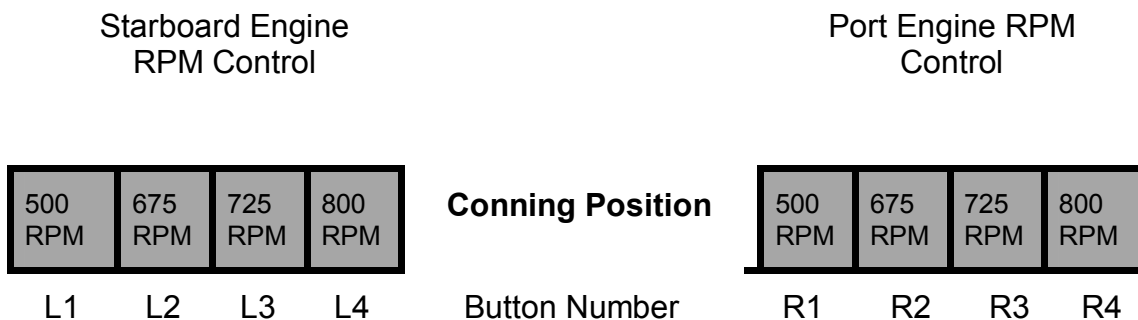
Figure 1: Aft control position

4. The Examination Panel are of the view that the most probable explanation for the asymmetric engine settings (Port 800 RPM and Starboard 500RPM) was as a result of a misinterpretation of the symmetry in the ergonomic layout of the engine speed settings as shown in Figure 1 below. The engine control buttons are mounted with other buttons and equipment in controls panels on either side of the conning position – as shown in Figure 2. The view of the Examination Panel is that the Mate would appear to have interpreted the buttons as being slower speeds to the inside and higher speeds to the outside. The VDR data shows that the Mate selected the two outer power settings (L1 and R4) rather than the far right setting on each bank of controls (L4 and R4).

7. The VDR data shows that the Mate has pushed L2 and R3 which would reinforce the view that the Mate believed that the power setting buttons were symmetrical about the conning position. In retrospect the Examination Panel can see how this confusion could have arisen.

Master instructing the Mate to “gee her more steamgee her the top one”. However, the pressing of the correct button, L4, for 800RPM on the starboard engine is contrary to the previous interpretation that the Mate believed the engine speed command buttons were symmetric around the Conning Position.

- The layout of the engine rpm command buttons is counter intuitive in that the left hand button on each console has the same function such that the buttons ramp up from left to right. Conversely a layout where control buttons ramped up from the inner to the outer could be confusing. Lastly, on the older tugs in the fleet there is only one set of engine rpm command buttons which controls both engines in parallel making an asymmetric setting impossible.
- Labelling of the control buttons was considered both small and not visible in poor light. This was highlighted as Critical Factor 3 in the report presented by TMS;
- Positioning of dials and readouts (for example the engine rpm tachometers) which can be difficult to see when operating the tug close to other vessels;
- Controls for operating the winch.

1. Work should continue to resolve and rectify the underlying cause of the directional instability.
2. Improve the labeling of the engine speed control buttons and consider a more effective layout
3. Prior to re-introduction to service, a comprehensive training programme to be put in place.
