# Rain Erosion Maps for Wind Turbines Based on Geographical Locations: A Case Study in Ireland and Britain

Article in *Journal of Bio- and Tribo-Corrosion* · March 2021

K. Pugh<sup>1</sup> · M. M. Stack<sup>1</sup>

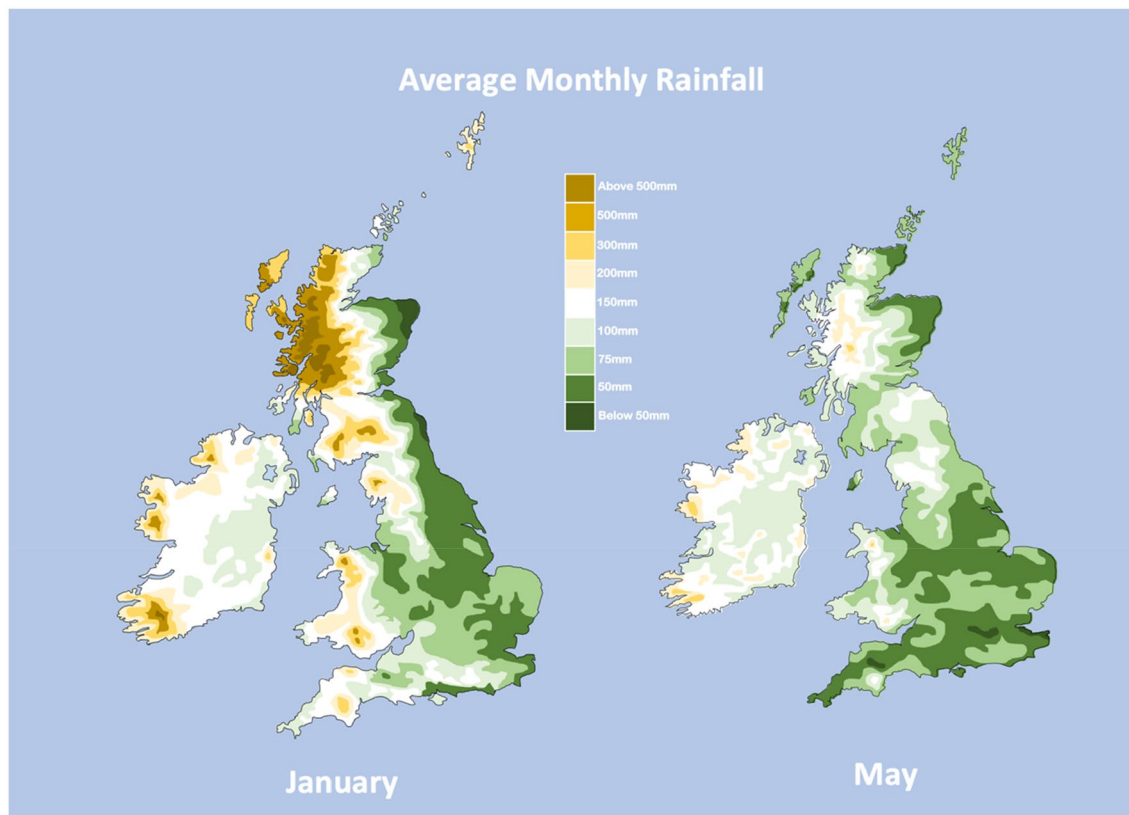
**Fig. 3** The average rainfall in the months of January and May

allow for contrast to be observed between the 2 months. The result of this can be seen in Fig. 3.

The construction of the rainfall map (Fig. 3) allows the setup for the experiment to be finalised. The key to the map displays: Below 50 mm, 50 mm, 75 mm, 100 mm, 150 mm, 200 mm, 300 mm, 500 mm and above 500 mm. The rainfall rate of the whirling arm rig is 50 mm/h therefore for the time each sample exposed to rain erosion can be determined, this is.

The rainfall mostly averages between 50 and 500 mm of rain with some few areas showing more extreme rain. It is clear that the month of May experiences considerably less rain as it shows highs of 300 mm whereas this rate is fairly common in January. The areas of intensity are very similar in both months with the west coast of Scotland showing a high rainfall and also the west coast of Ireland, predominantly the south west coast of Ireland displaying very heavy rainfall. These are historically harsher climates due to the prominent westerly wind from the Atlantic [12]. This leads to further erosion as the largest windfarms are located in these areas due to the increased power output from the consistent wind [13]. This is a very common trade-off when building a windfarm as the conditions that yield the most power generation are also the conditions which deteriorate the turbine blades most rapidly, therefore the life of the turbine blade will be reduced [14].
